# County of Santa Cruz

## GENERAL SERVICES DEPARTMENT

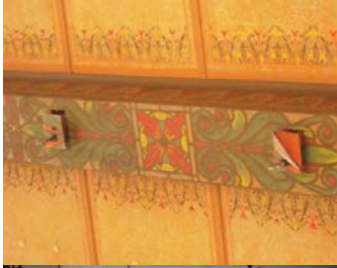
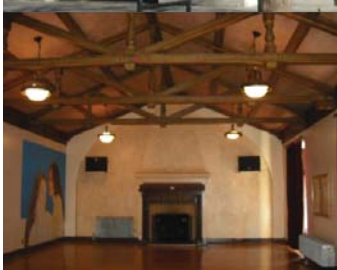
### Repair Project Report

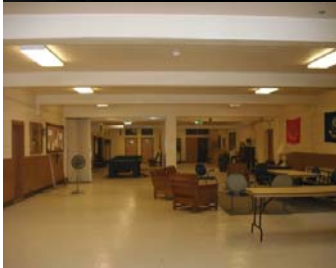
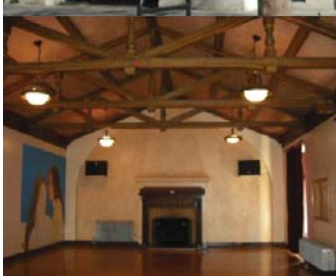
Task 6 .....	17
Task 7 .....	18
Base Repair Project	
Upgrade Items	
Task 8 .....	19

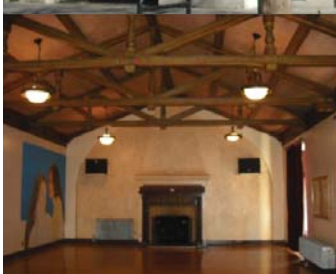
## REPAIR PROJECT REPORT

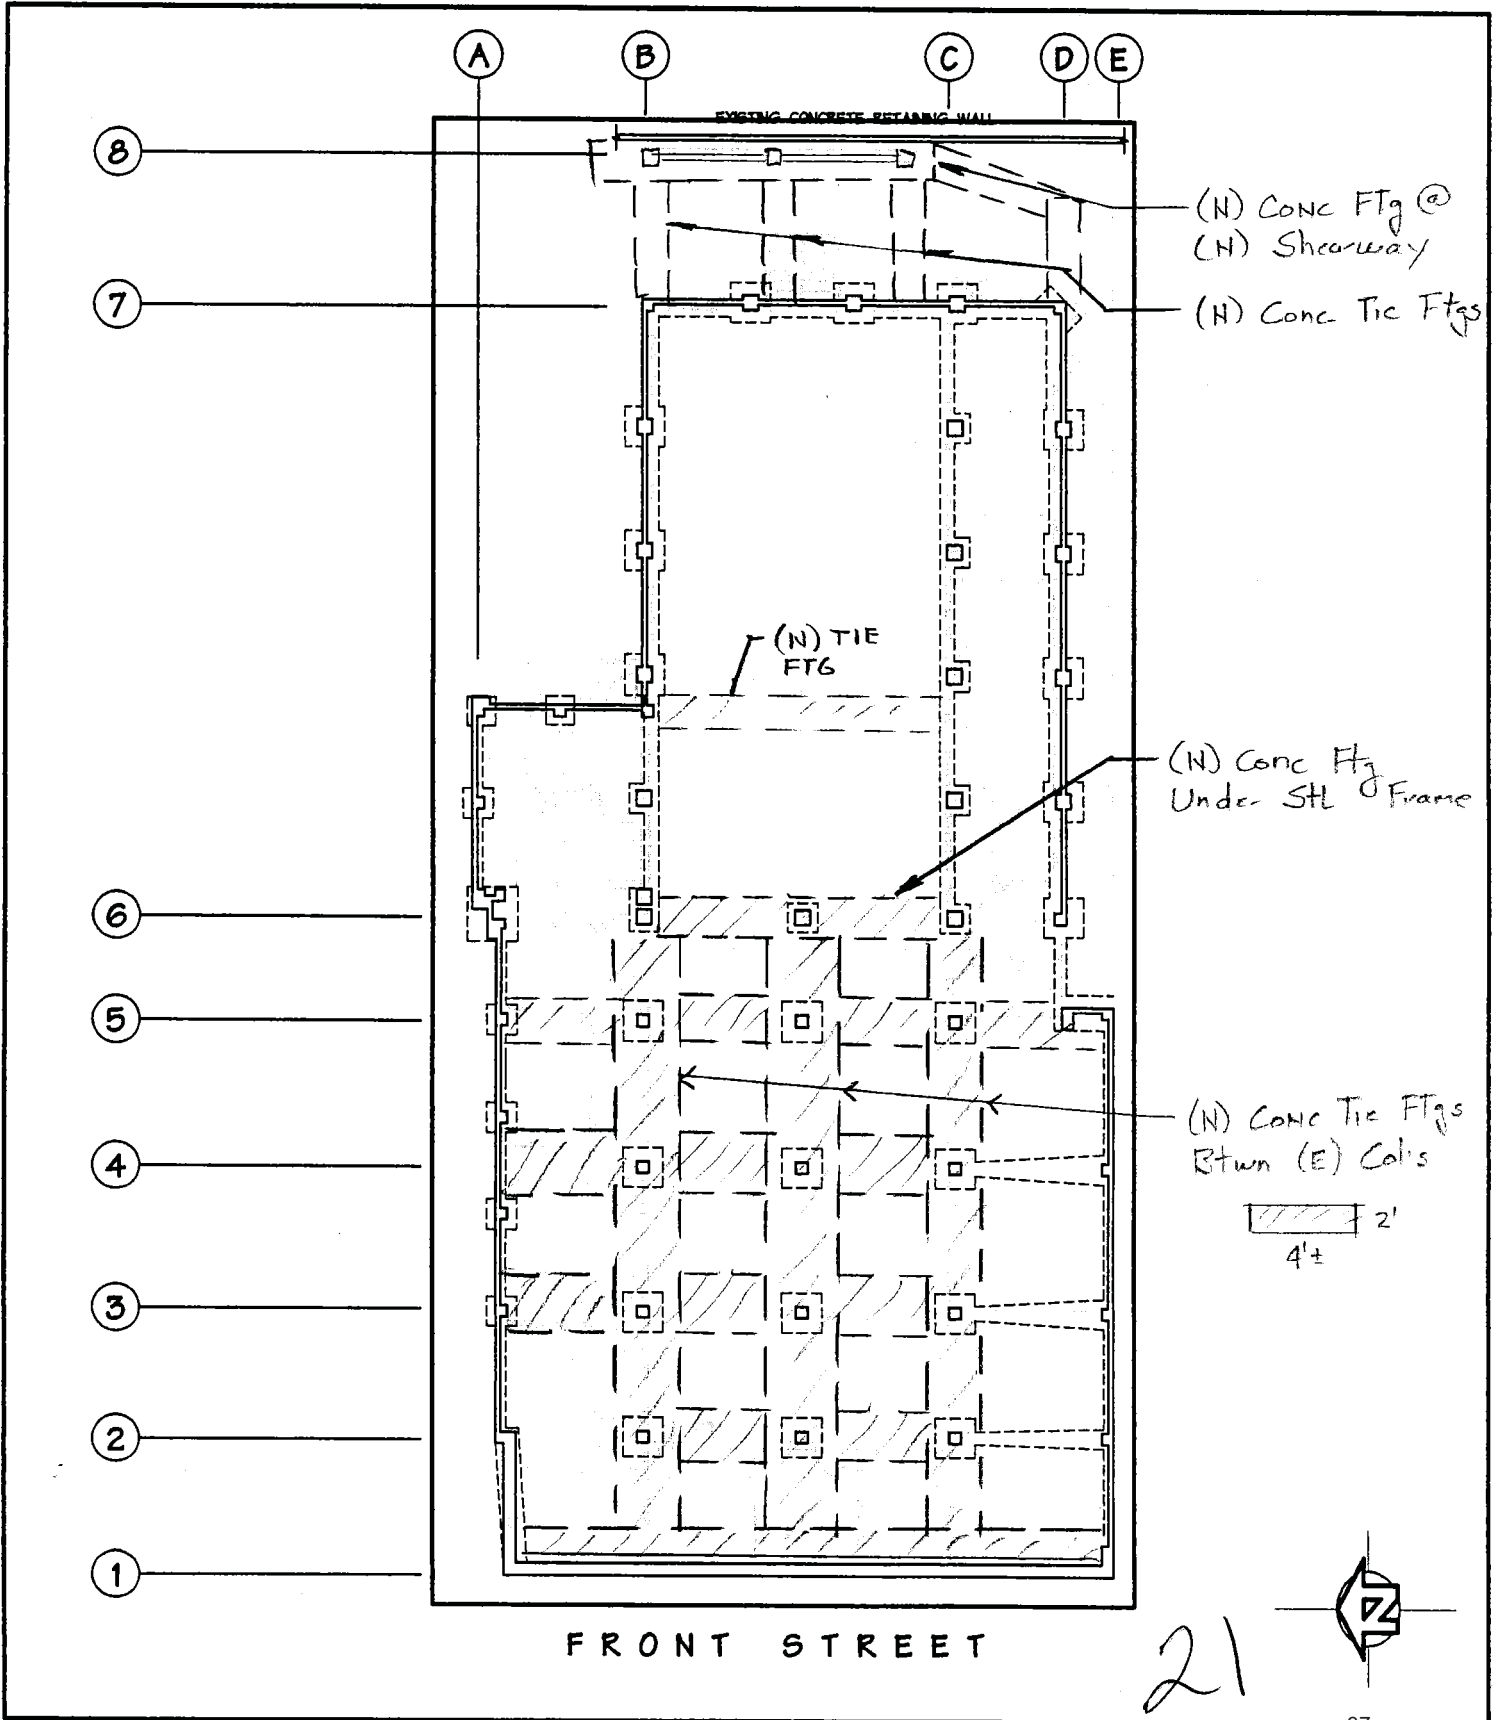
JOB 10002 - Veterans Hall  
SHEET NO. Partial Foundation Plan  
CALCULATED BY \_\_\_\_\_ DATE \_\_\_\_\_  
CHECKED BY \_\_\_\_\_ DATE \_\_\_\_\_  
SCALE \_\_\_\_\_

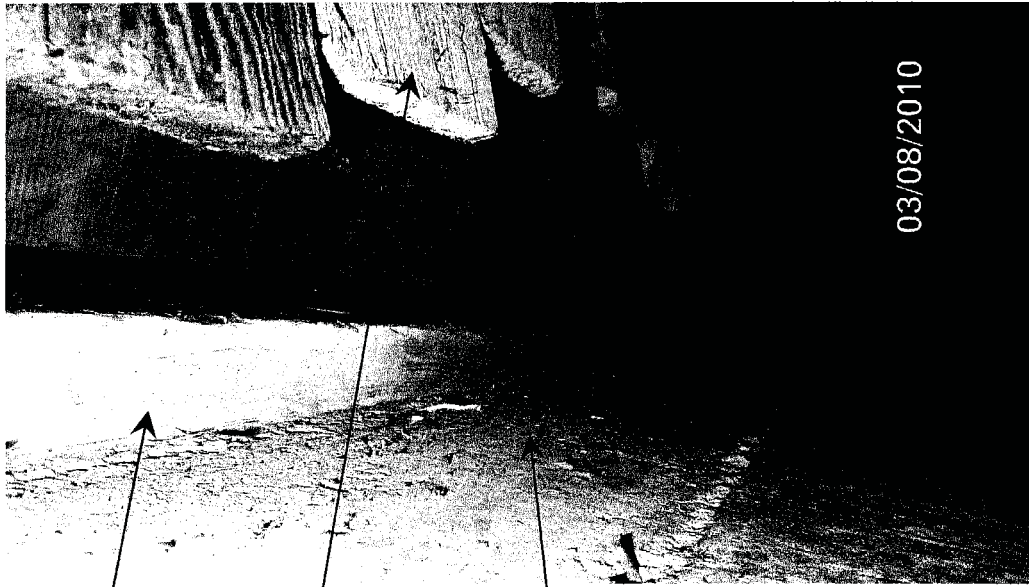
Cricket ledger no connection noted to wall

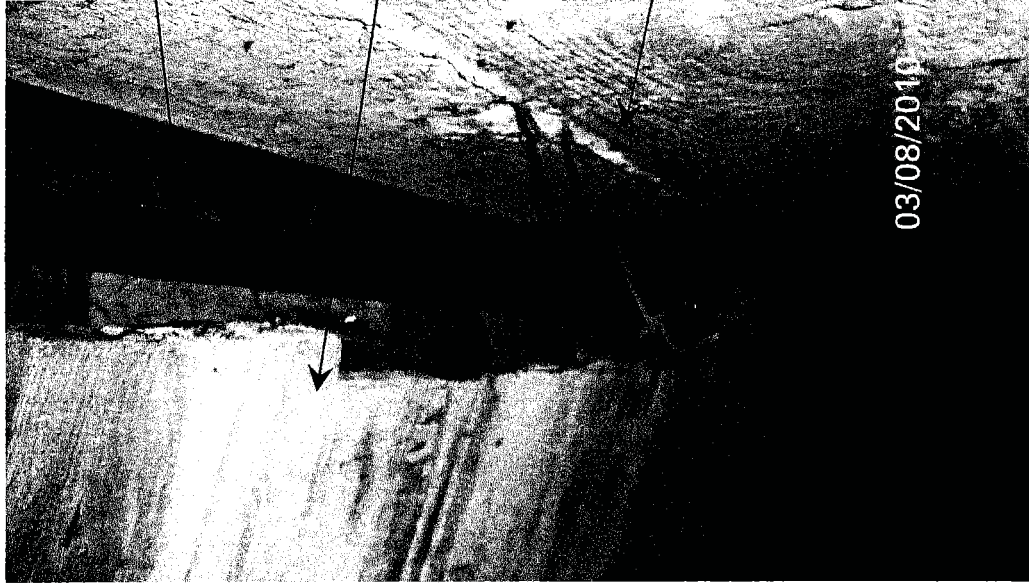
Cricket ledger no connection noted to wall

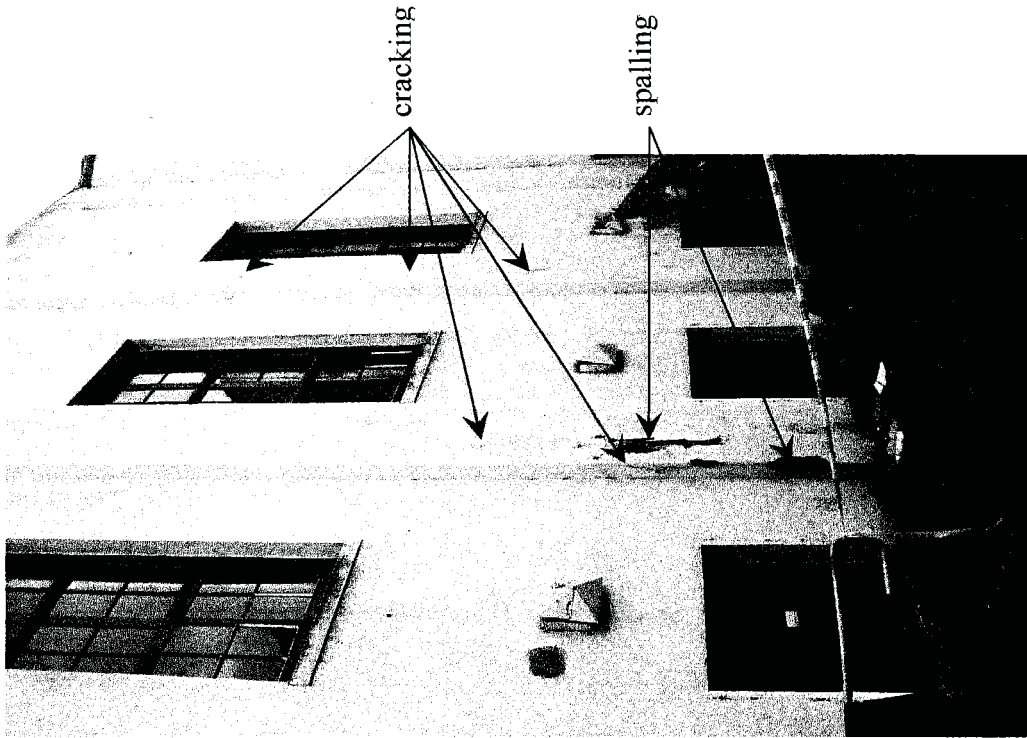
SPALLING OF CONCRETE AT PILASTER

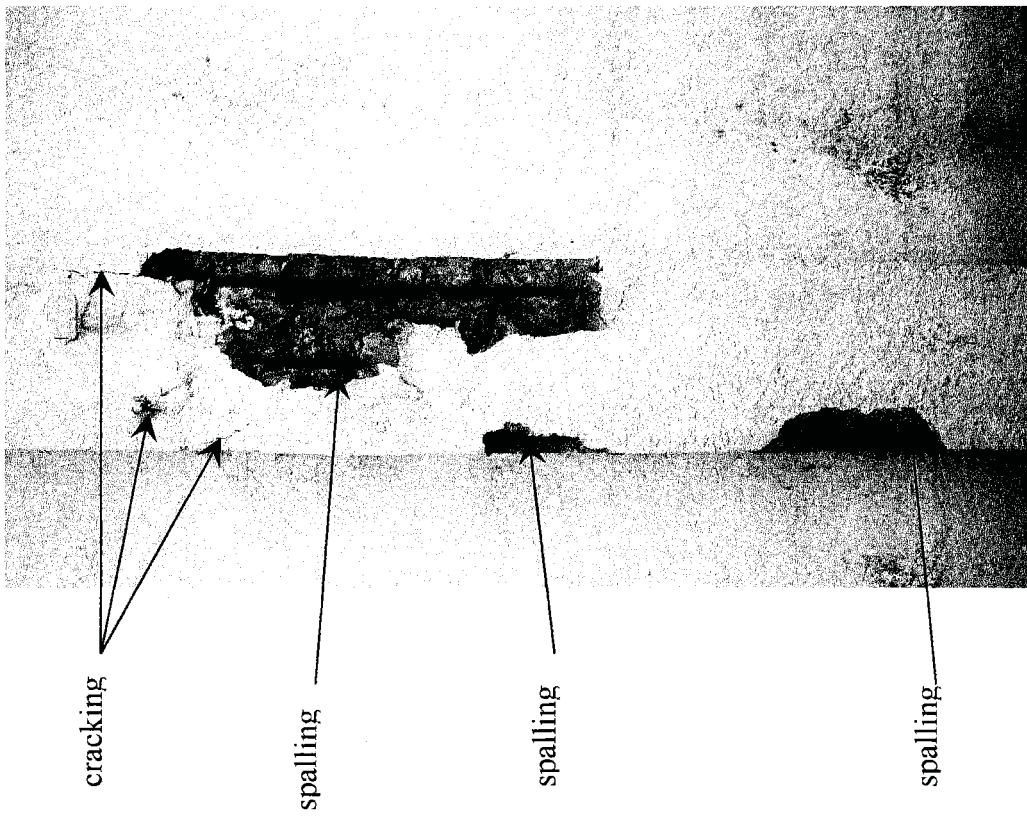
SPALLING OF CONCRETE AT PILASTER

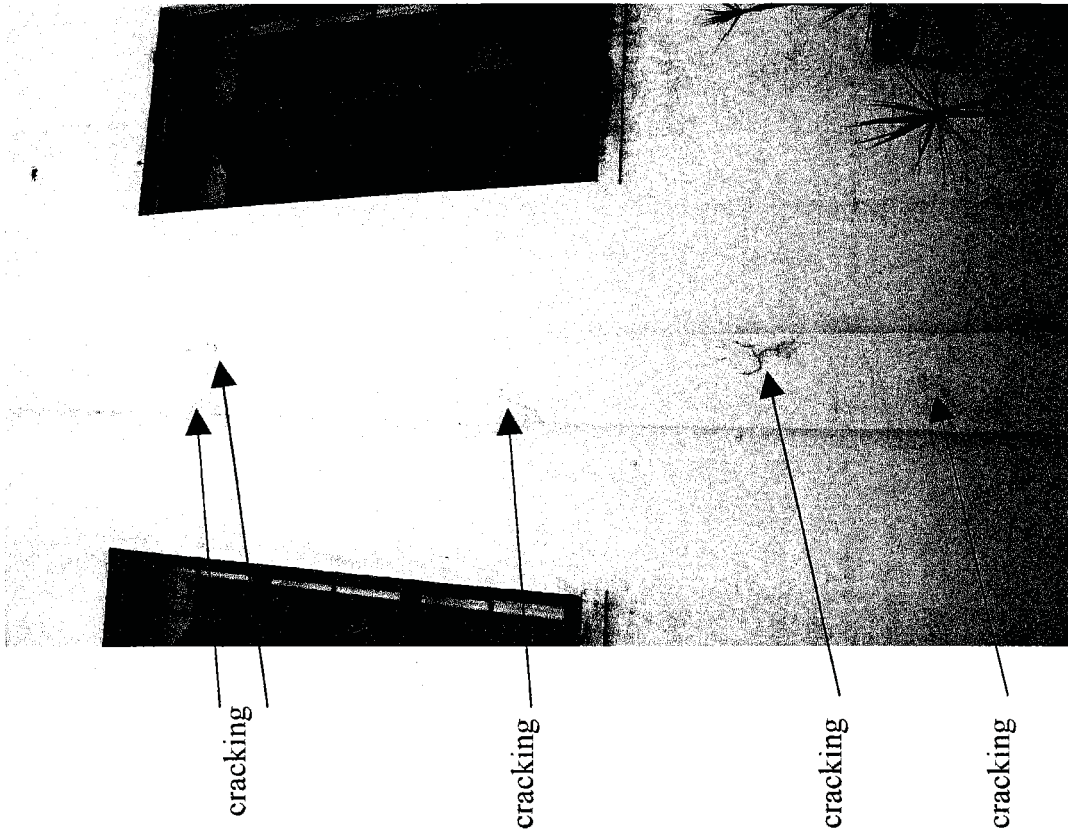
CRACKING OF CONCRETE AT PILASTER

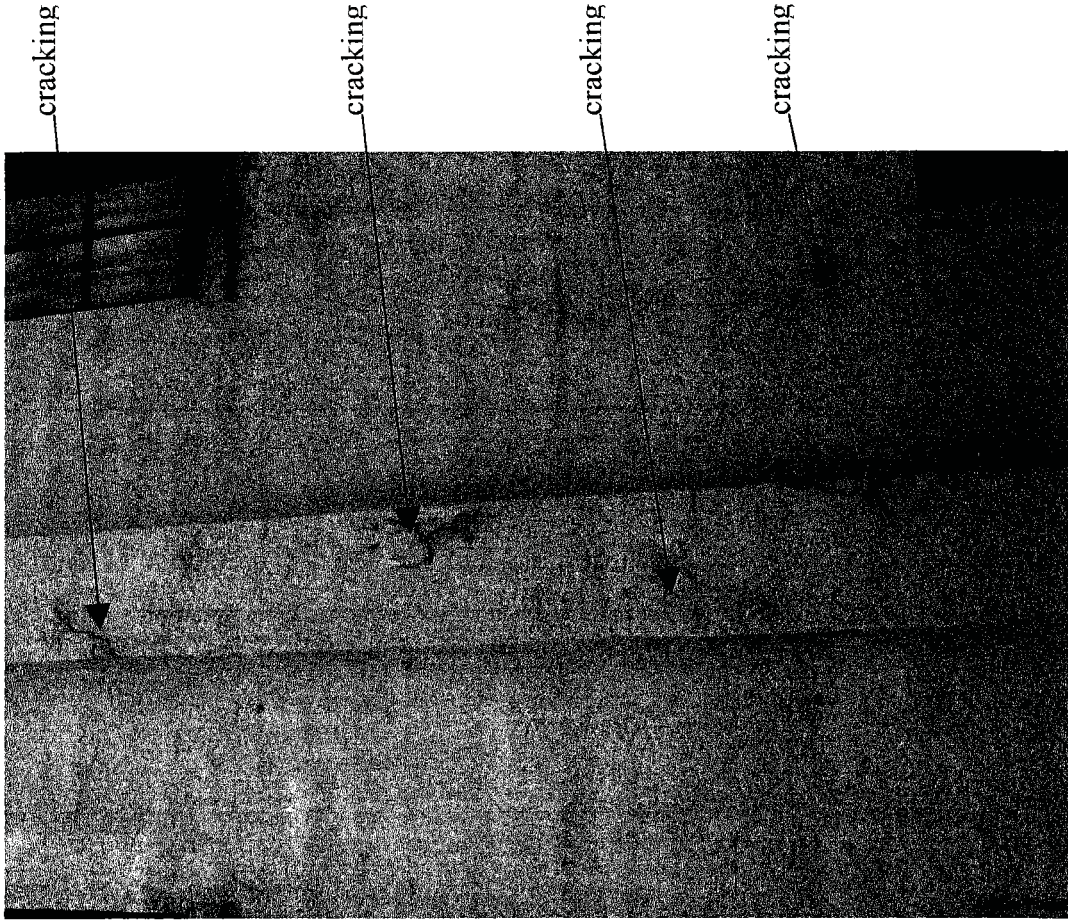
CRACKING OF CONCRETE AT PILASTER

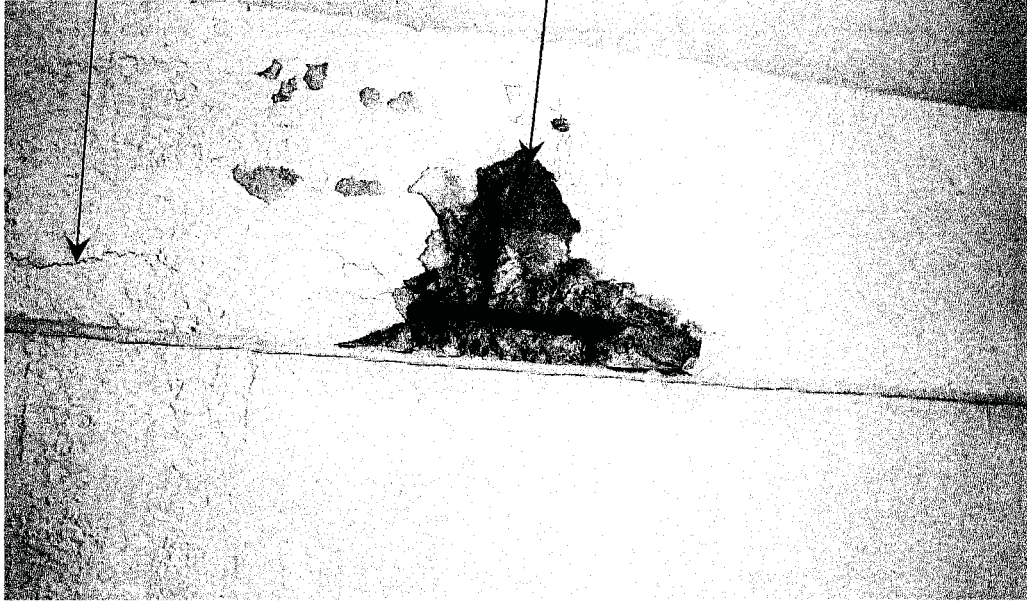
SPALLING OF CONCRETE AT PILASTER

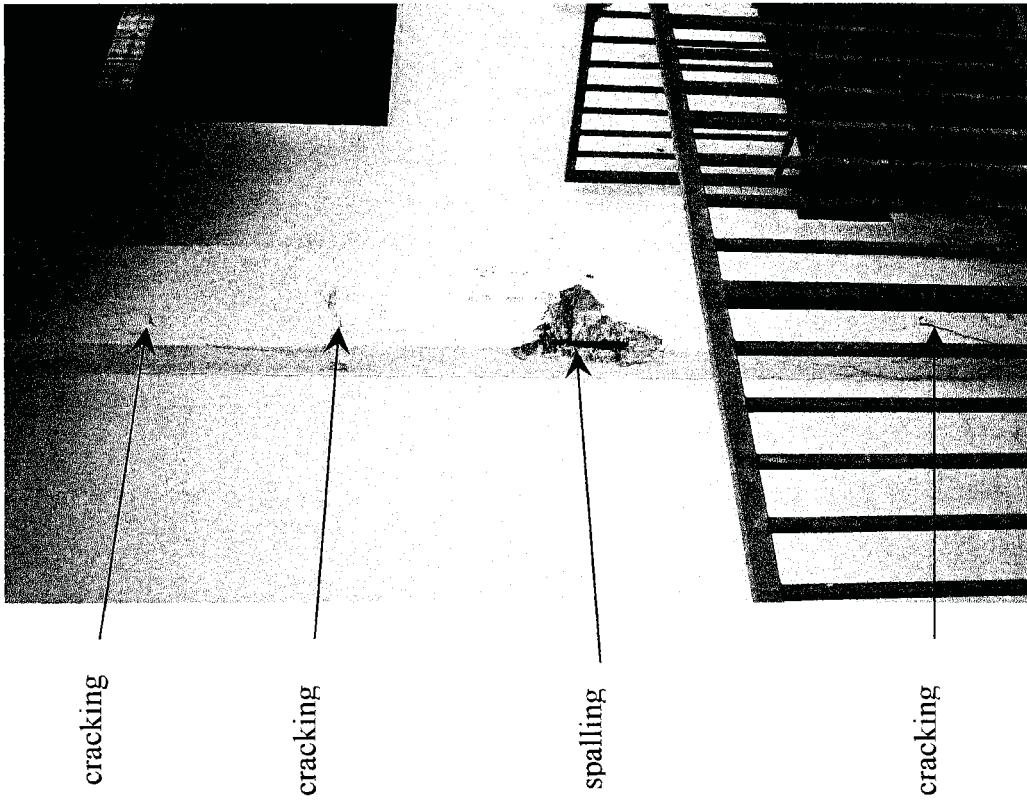
SPALLING OF CONCRETE AT PILASTER

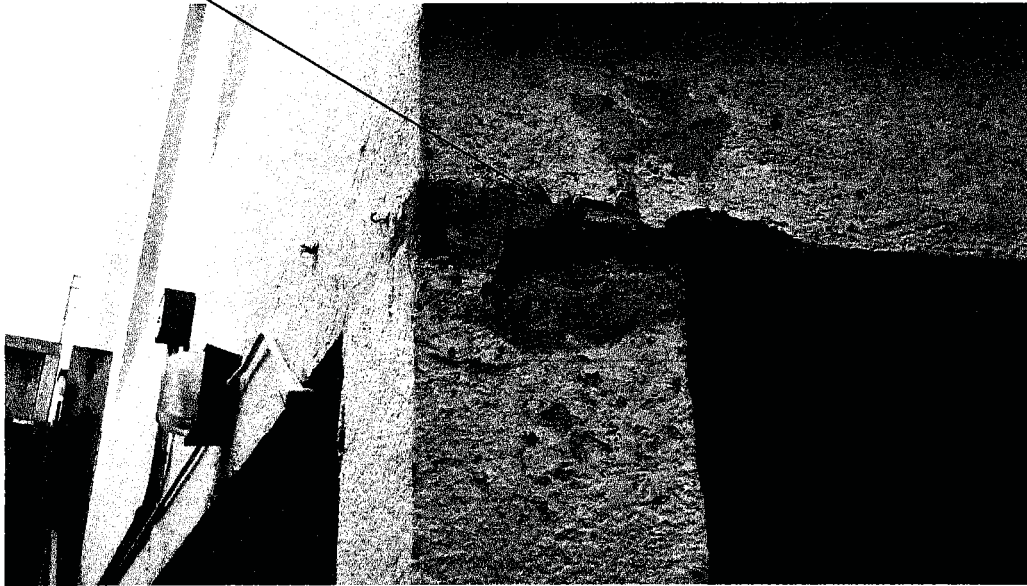
STAGE ADDITION CONCRETE COLUMN SPALLING

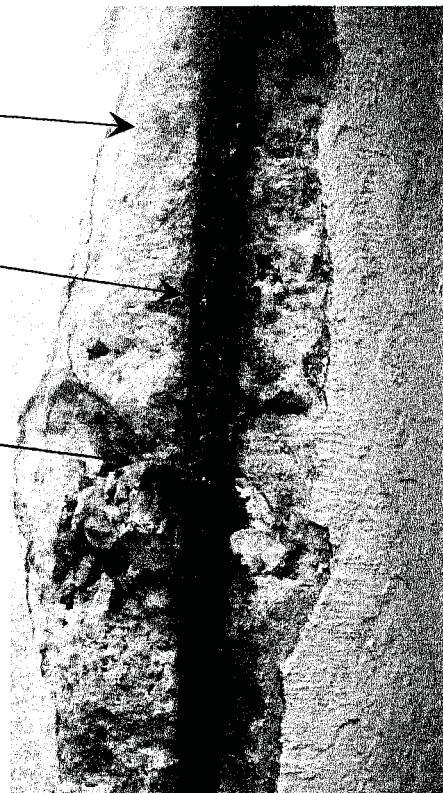
STAGE ADDITION CONCRETE COLUMN  
SPALLING AND REINFORCEMENT CORROSION

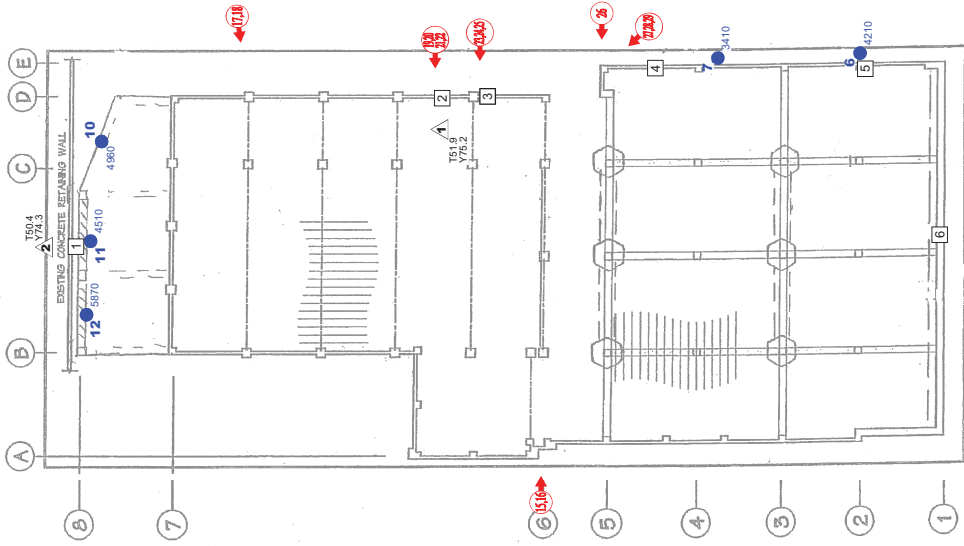
PROJECT NO.: 9185.000.000		1
SCALE: AS SHOWN 141		
DRAWN BY: DLB	CHECKED BY: CM

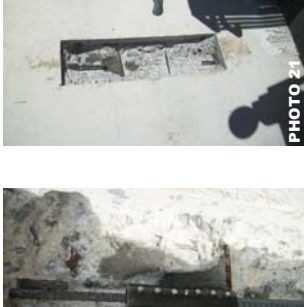
PHOTO 18  
SOUTH WALL, 1ST LEVEL PILASTER AT D-6.3 REPAIR

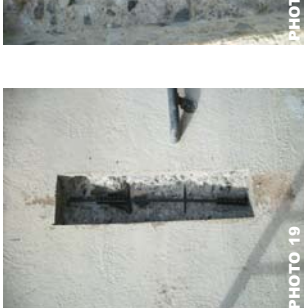
PHOTO 19  
SOUTH WALL, 1ST LEVEL AT D-6.3 REPAIR

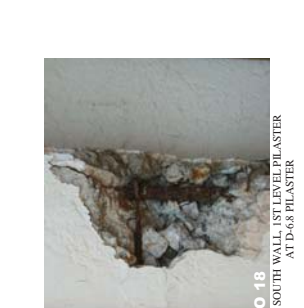
PHOTO 20  
SOUTH WALL, 1ST LEVEL PILASTER AT D-6.8 PILASTER

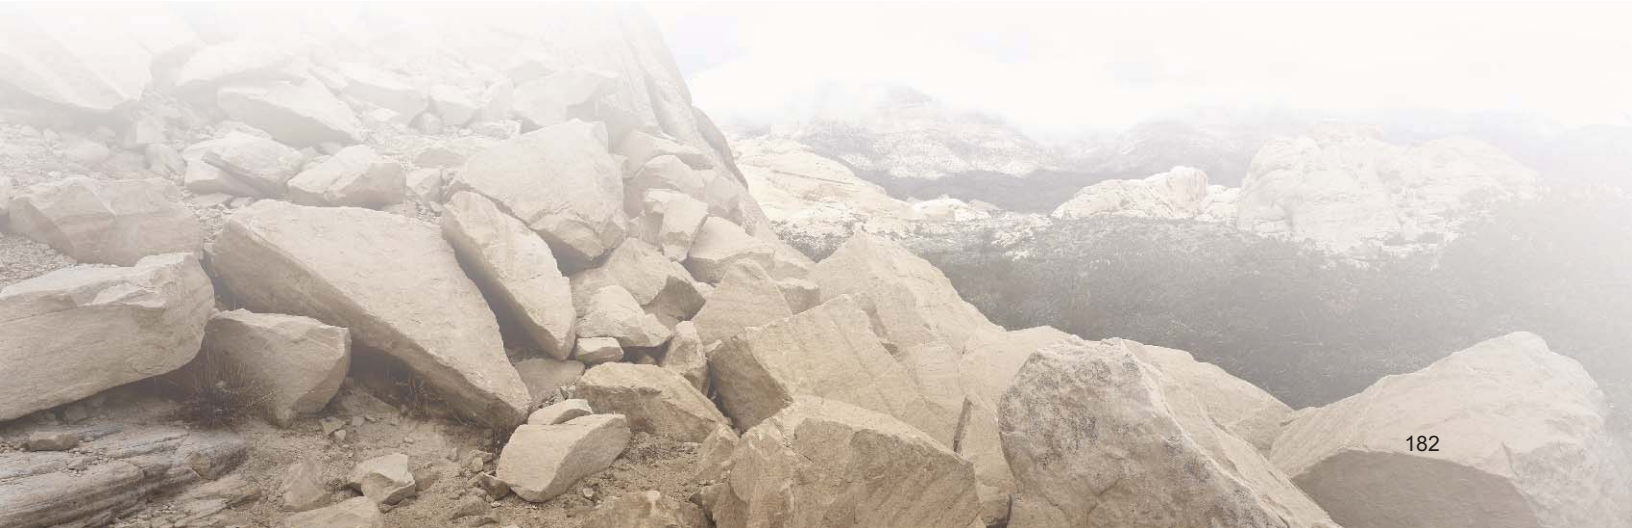
**MOISTURE-DENSITY TESTS**

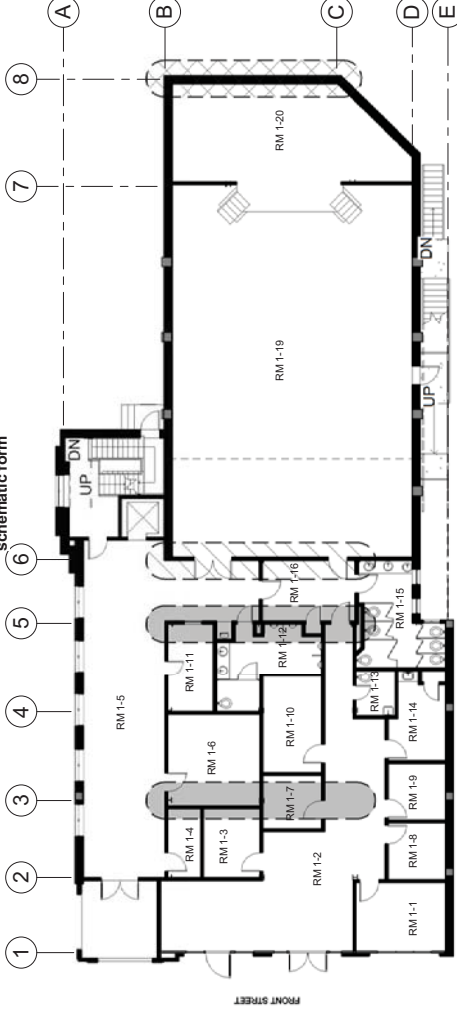
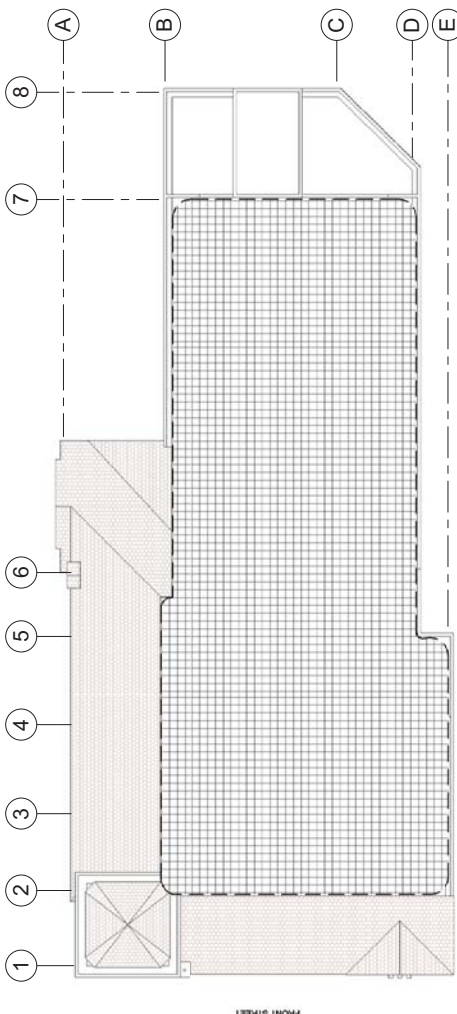
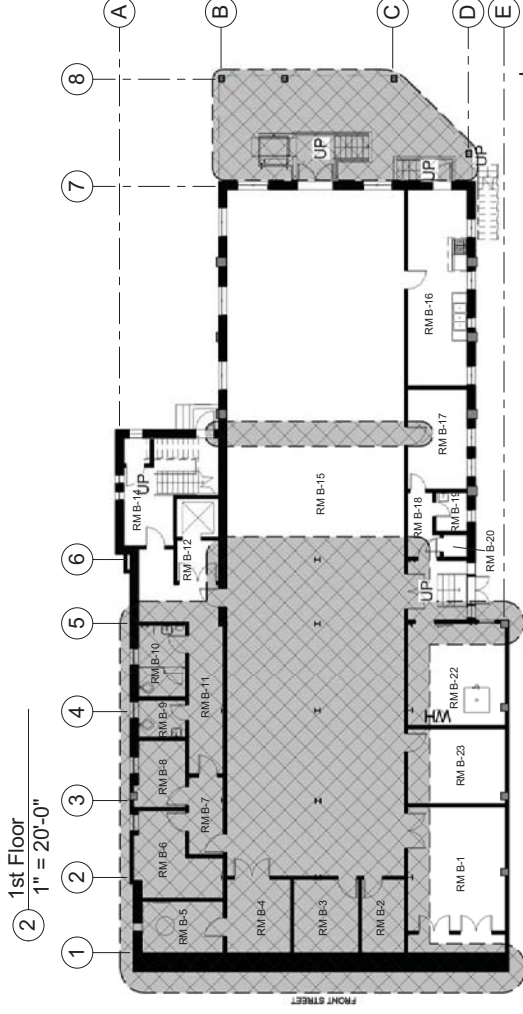
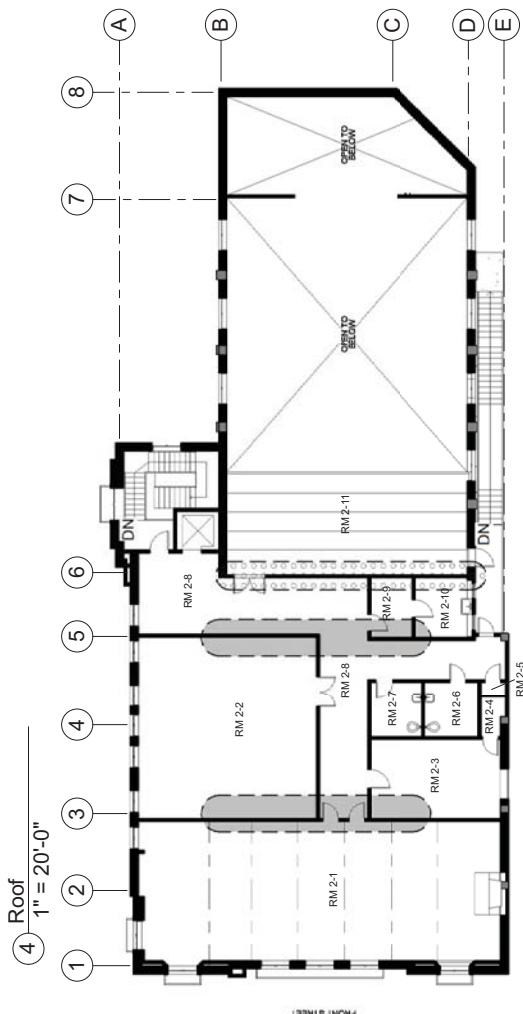
4540 Duckhorn Drive, Suite 300  
Sacramento, CA 95834  
TEL 916-575-8888  
FAX 916-575-8887  
228

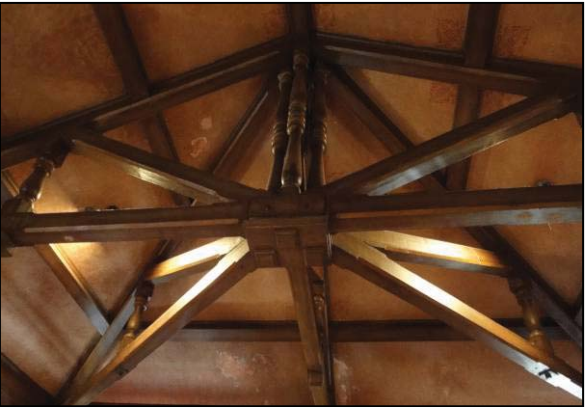
Bill Motto ceiling framing detail

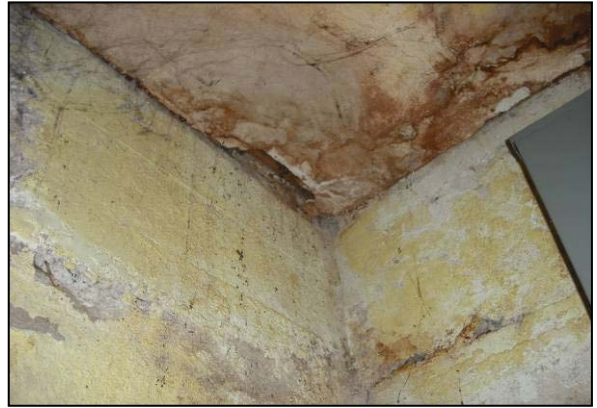
Interior spalling & stain ceiling

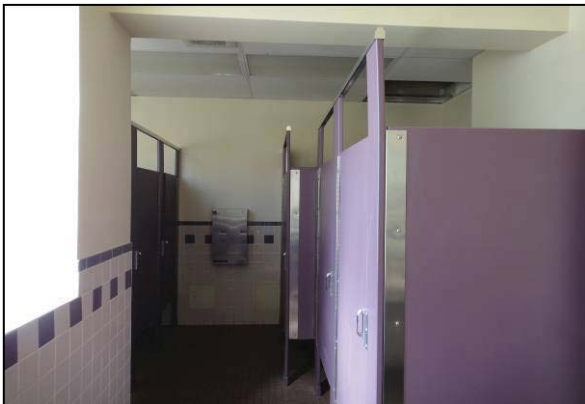
1<sup>st</sup> floor women's room
